## Nuplex

### Tanking / Below ground waterproofing - Troubleshooting

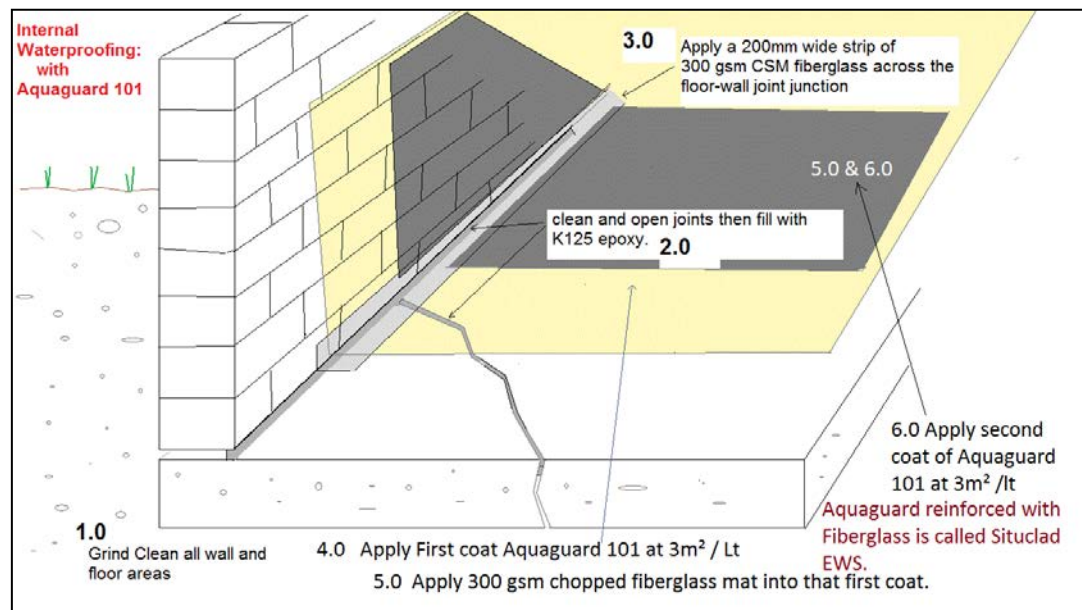
Carefully follow instructions including using a fillet of K102 / K125 epoxy at the internal wall / floor interface. Also then laminate that interface with fiberglass. Then Aquaguard the full wall. Two coats at 3m<sup>2</sup> / Lt / coat. Two coats. A full wall and floor laminate is most effective ( Situclad EWS).

Use Aquaguard 101 system. This is a water based epoxy coating. Refer data.
